# **APPLICATIONS DEVELOPMENT OF CONCRETE POLYMER MATERIALS — A SUMMARY REPORT**

**U. S. Department of the Interior  
Bureau of Reclamation**

1. REPORT NO. REC-ERC-84-21		2. GOVERNMENT ACCESSION NO.		3. RECIPIENT'S CATALOG NO.	
4. TITLE AND SUBTITLE  Applications Development of Concrete Polymer Materials- A Summary Report		5. REPORT DATE February 1985		6. PERFORMING ORGANIZATION CODE D-1510

**APPLICATIONS DEVELOPMENT OF  
CONCRETE POLYMER MATERIALS-  
A SUMMARY REPORT**

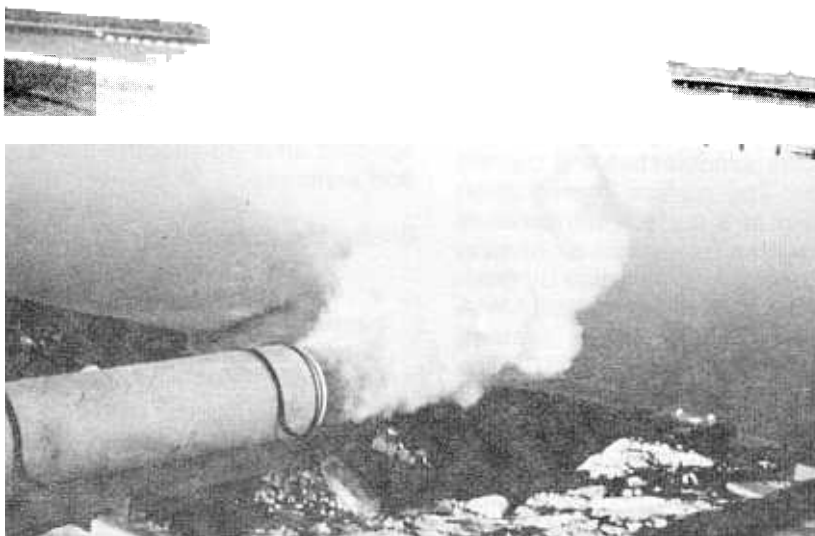
Bypass No. 1 showed thermal cracking shortly after being put into service, but no water or steam escaped through the cracks (see on fig. 5). Bypasses

Figure 5. — End of bypass No. 1 pipe discharging waste steam. Cracking caused by thermal stresses occurred shortly after the pipe was put into service. Photo 801-D-80849

No. 2 and 3 were pressure tested to 0.483 MPa upon completion. The PIC in No. 3 had a few pinhole leaks, but these later sealed. The PIAC did not leak. It was concluded that PIC and PIAC pipes must be brought to service temperatures gradually to avoid thermal

shock or distress that could cause damage, as occurred in bypass No. 1.

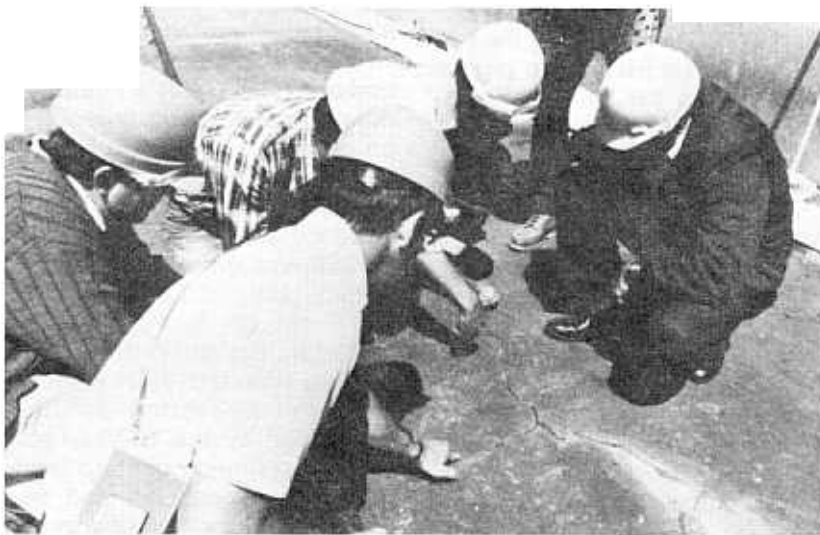
Figure 10. – Pattern cracking the the VE PC overlay examined by research and field personnel. Photo 801-D-80853

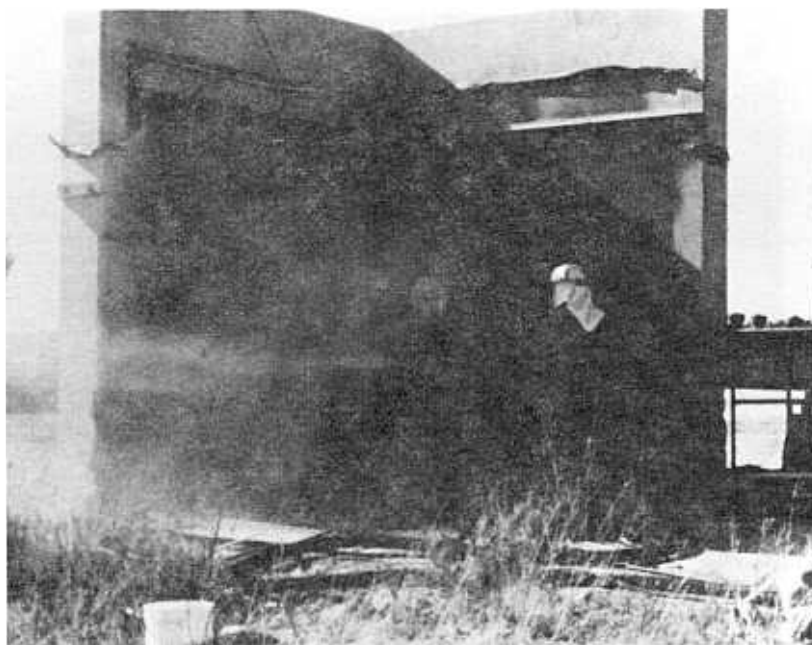
Figure 20. — Trial application of low-viscosity VE polymer shotcrete. The high loss of fines caused a poor, nonuniform application. Photo 801-D-80863

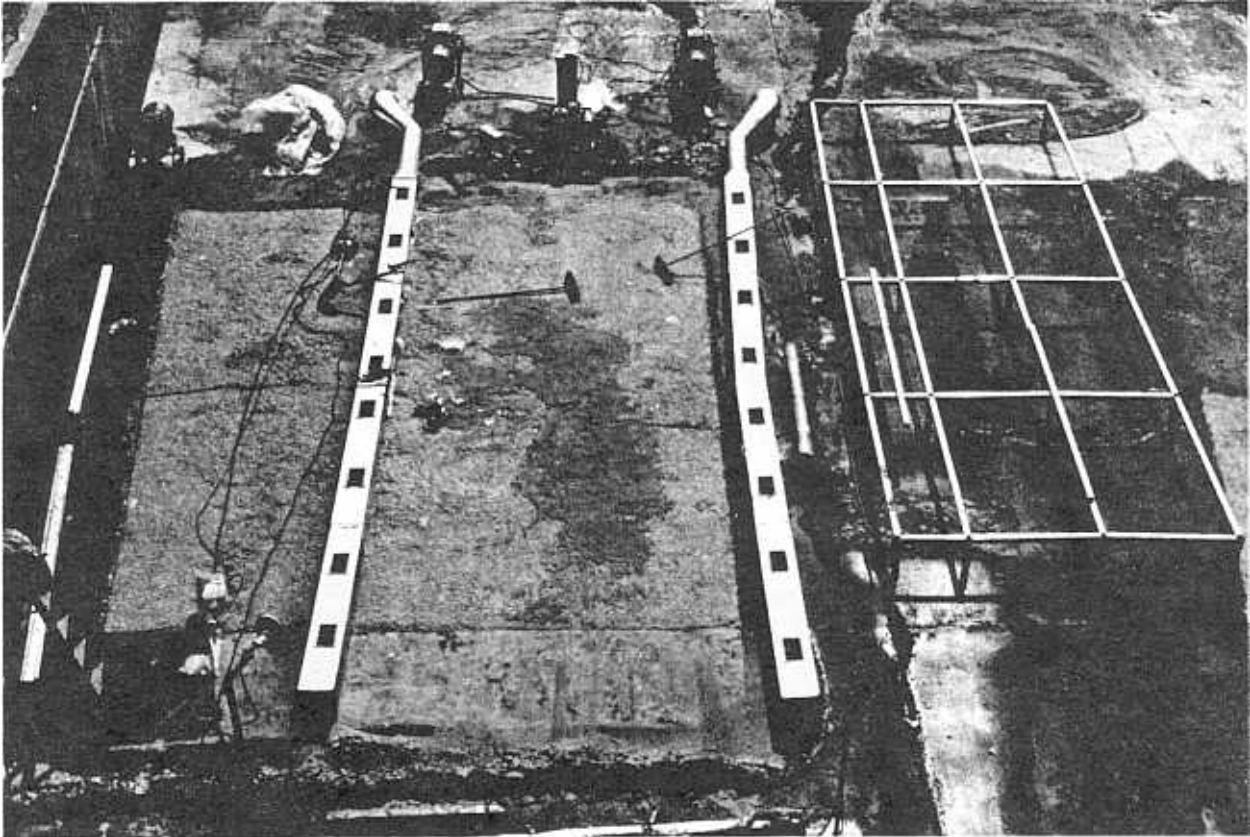
Figure 9. - The surface-impregnated area is shown after completion of the polymerization cycle. The irregular-shaped patch was formed by sand bonded to the concrete by excess polymer.

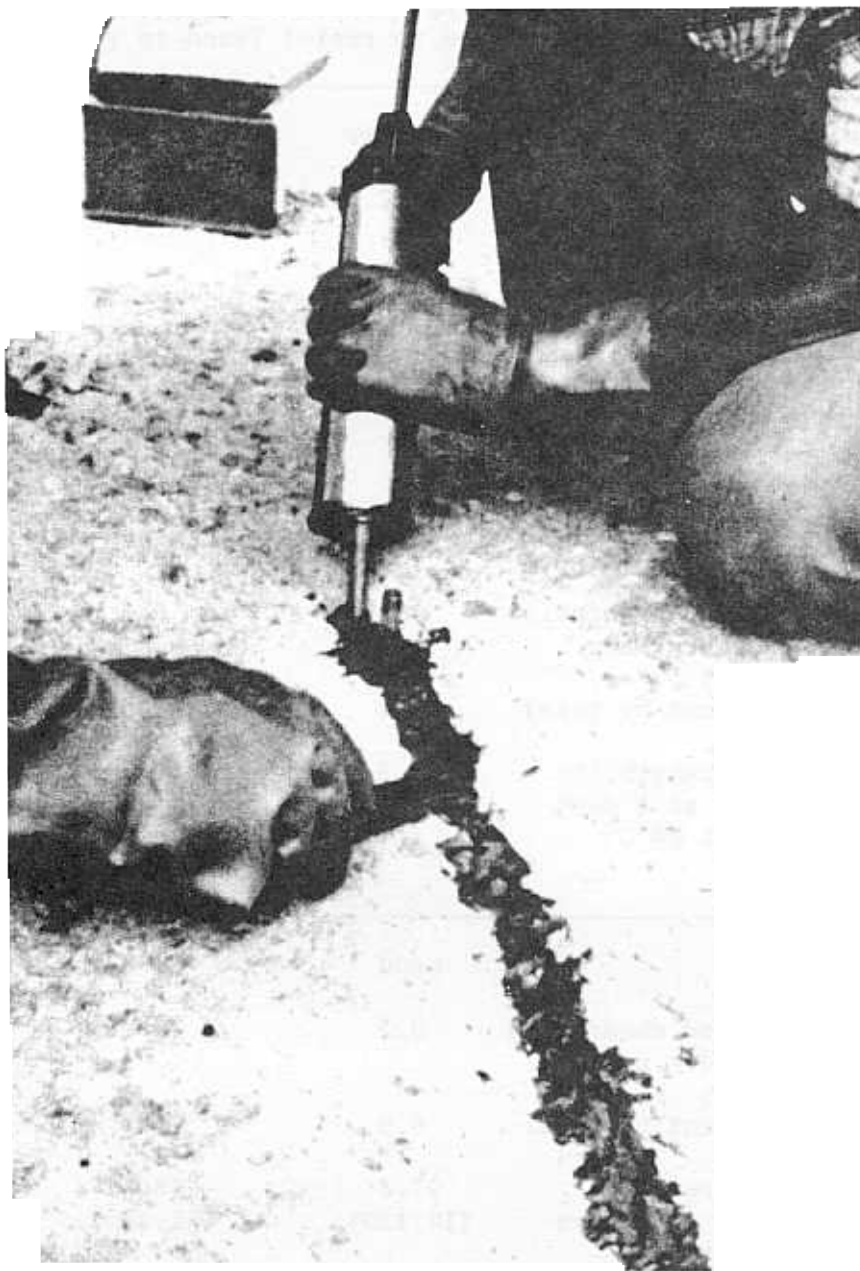
Figure 15. - Crack in concrete on spillway floor is being sealed with epoxy paste in preparation for epoxy resin injection. Note the injection nipples through which epoxy is later to be injected.

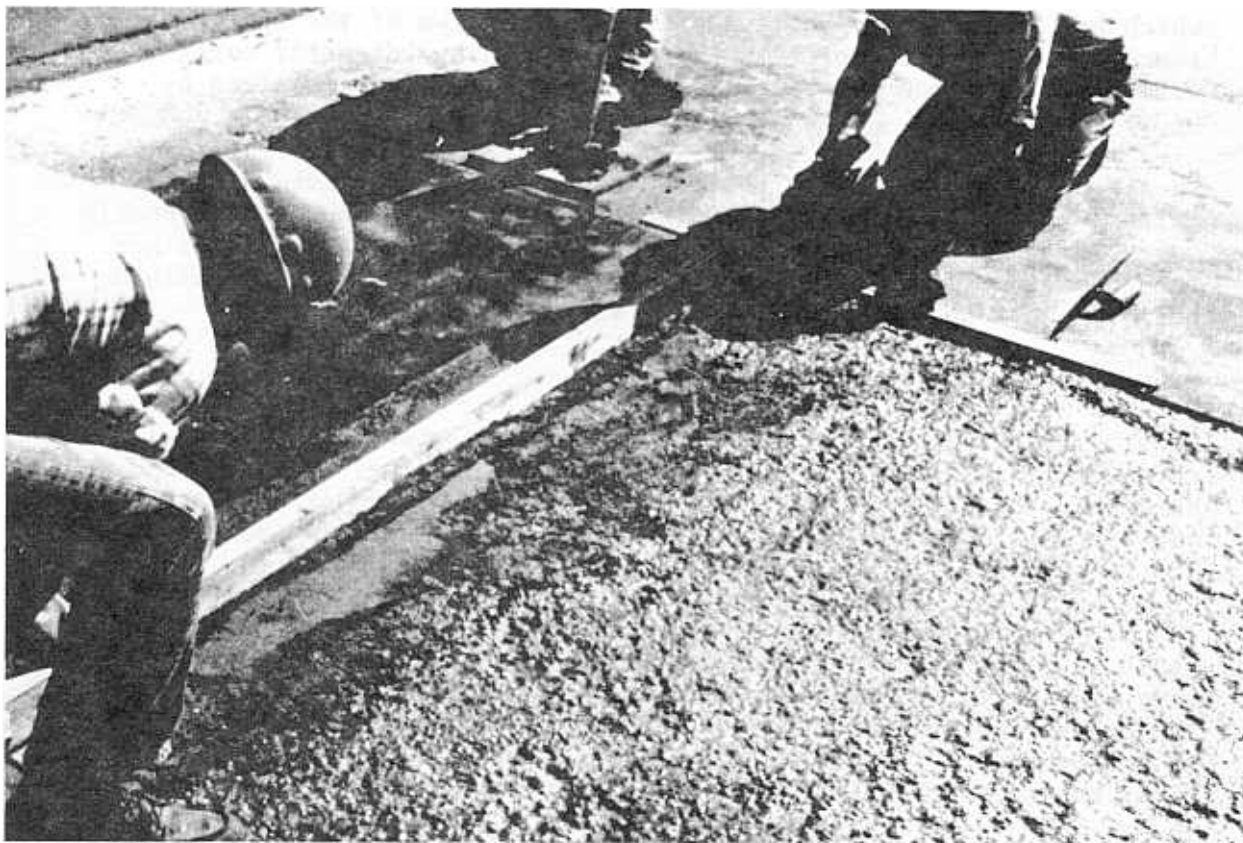
Figure 19. - Epoxy mortar is being screeded over the freshly placed epoxy bond coat on the concrete surface. Note the milky appearance of the epoxy resin bond coat, which is caused by the presence of water on the concrete surface.
